# Safety Inspection Report

Annual Inspection

## School Playing Field

04 January 2024

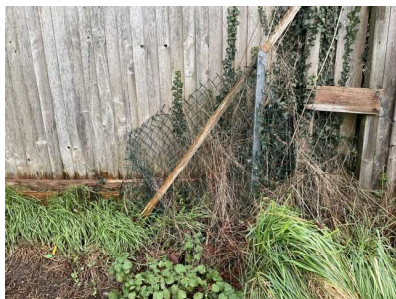
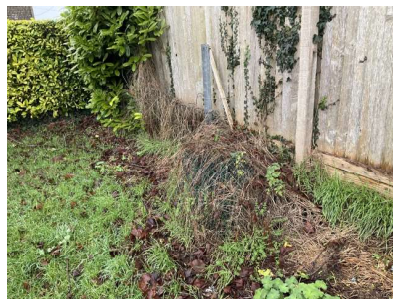
Additional comments are noted below.

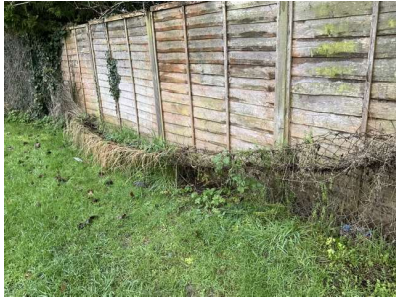
Minor repairs are needed.

Repair.

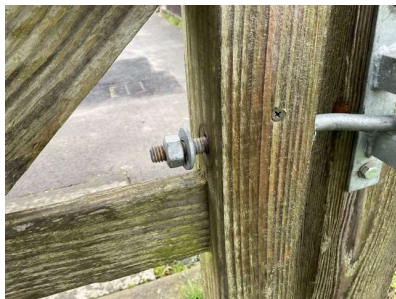
Fixtures loose or missing.

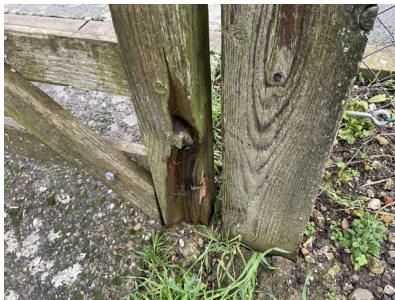
Item is damaged.

Repair.

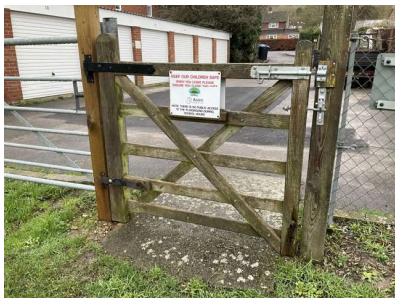
Additional comments are noted below.

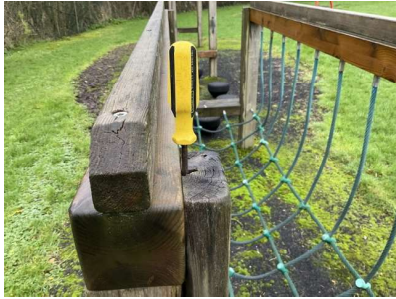
Timber is decayed.

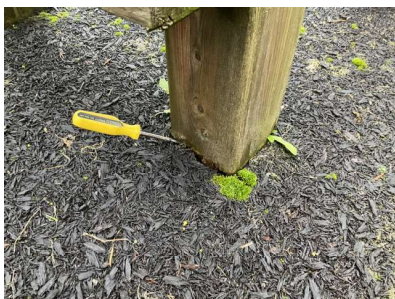
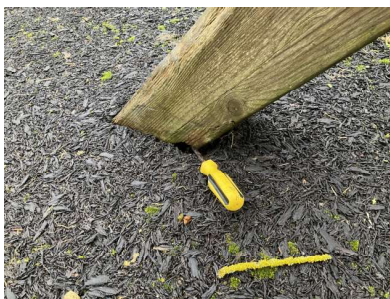
# Bridge - Rope

Timber is decayed.

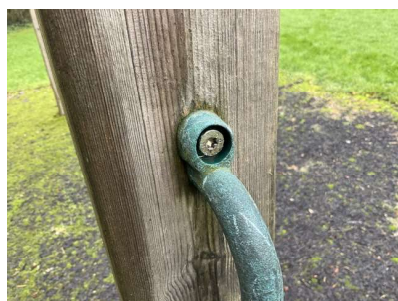
# Climber - Overhead - Suspended Rings

Bolt cap damaged.

Replace.

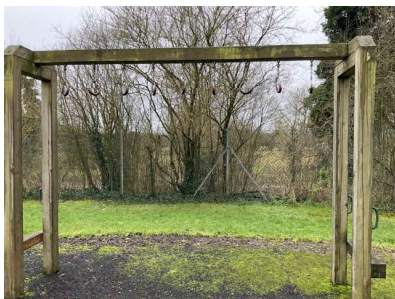
The protective surface under all bars and rings must be kept in good condition.

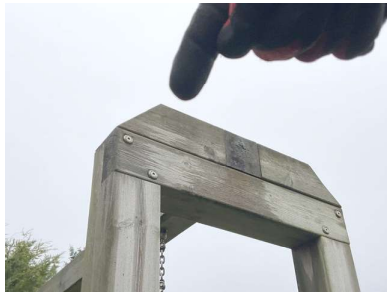
This is the only other high level piece in the timber trail of 5 pieces, The 2024 ROSPA report noted that much of the timber is decaying see photos)

Timber is decayed.

### **Recommend removal of the rings to put the equipment out of action**

Repair.

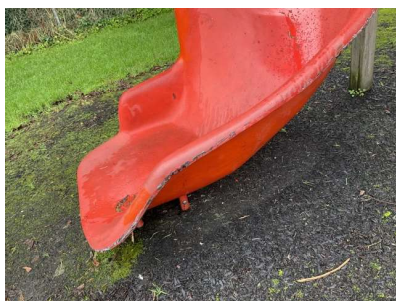
# Multiplay

Item has some parts missing.

Replace the missing parts.

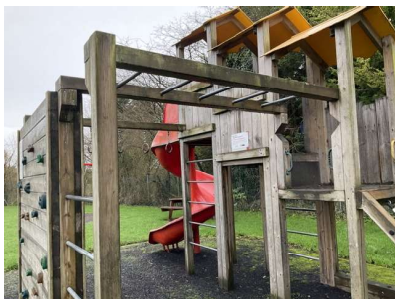
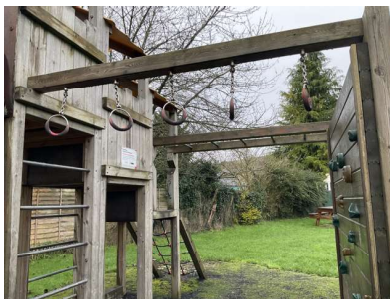
The protective surface under all bars and rings must be kept in good condition.

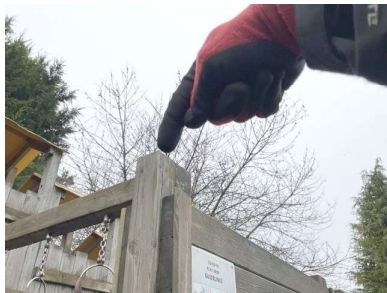
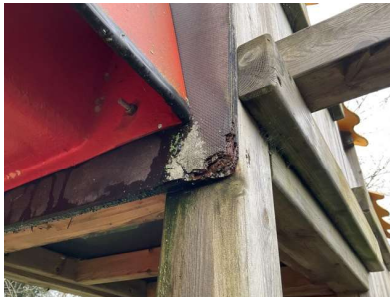
Timber is decayed.

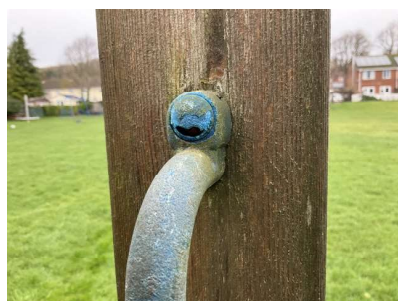
# Suspended Log Walk

Bolt cap damaged.

Replace.

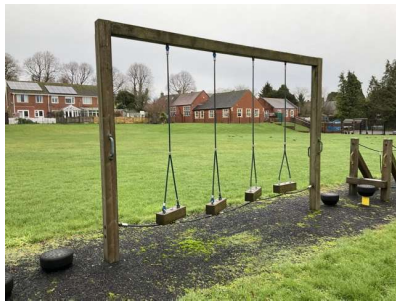
This equipment relies on one post for its stability. Special attention should be paid to maintenance (e.g. by monitoring degradation) and if necessary decommissioning the item before the end of its operating life.

Routinely check for decay.

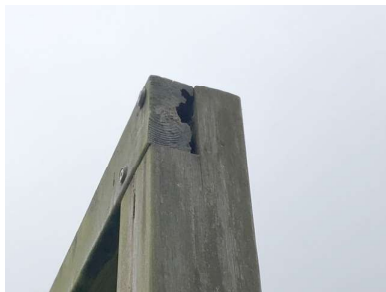
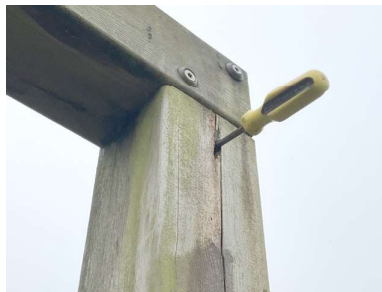
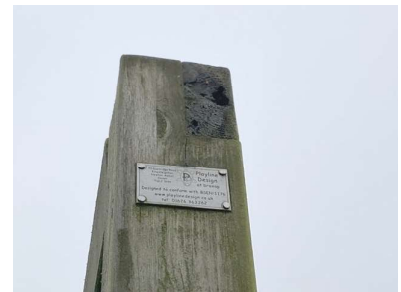
Timber is decayed.

Decaying around fixing points and top of vertical post.

Replace affected parts.

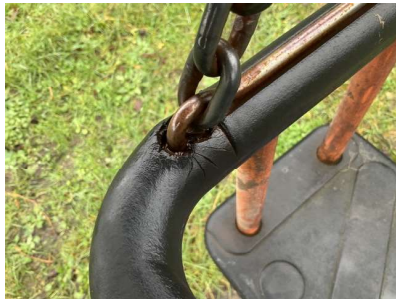
# Swing - Mixed - 2 Bay 2 Junior 2 Toddler Seat

The bars on one of the cradle swing seats has failed and both chains have moved to one side of the seat, the links on the chain are worn, the half bar half chain is no longer used

Corrosion in cradle seat top frame could lead to sudden failure of the seat.

**Recommended council replaces 4 sets of chains and 2 cradle seats**

Investigate and replace as necessary.

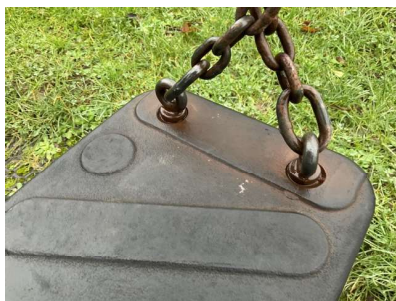
Loose swing seat eye-bolts.

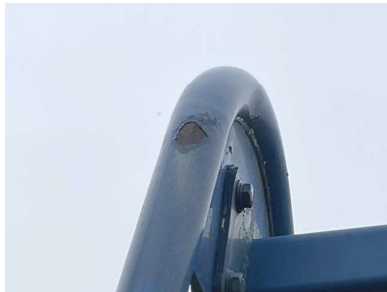
Item has corrosion.

Treat and repair.
