| Name authority: | Heytesbury Imber & Knook PC |

## **February OS report**

# Safety Inspection Report

Site name: **School Playing Field**  
Date of inspection: **04 January 2024**  
Inspector: **Jonathan Peters**

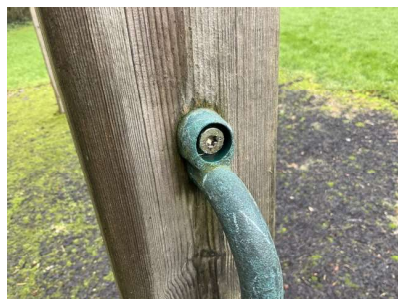
This is the only other high level piece in the timber trail of 5 pieces, The 2024 ROSPA report noted that much of the timber is decaying see photos)

Bolt cap damaged.

### **Recommend removal of the rings to put the equipment out of action**

Replace.

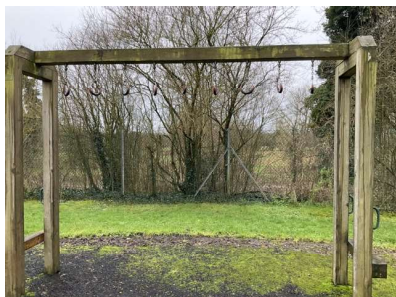
The protective surface under all bars and rings must be kept in good condition.

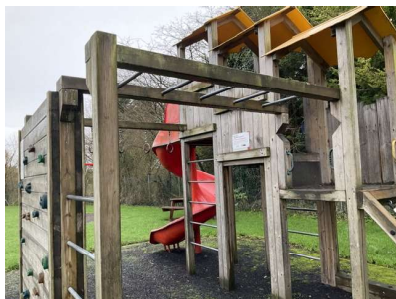
The protective surface under all bars and rings must be kept in good condition.

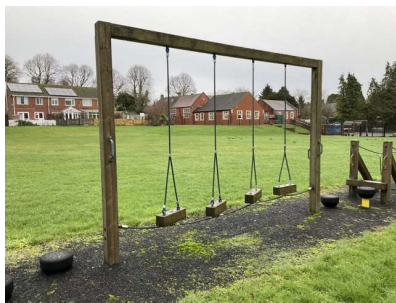
This equipment relies on one post for its stability. Special attention should be paid to maintenance (e.g. by monitoring degradation) and if necessary decommissioning the item before the end of its operating life.

Routinely check for decay.

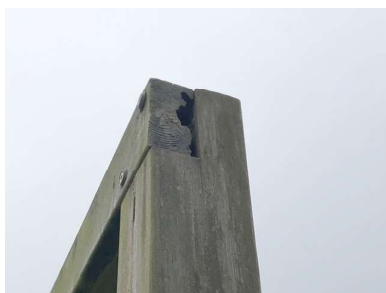
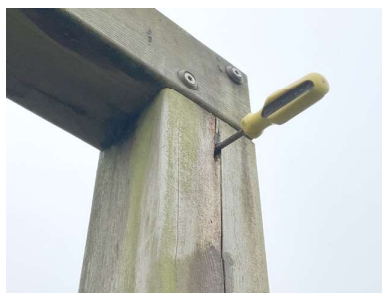
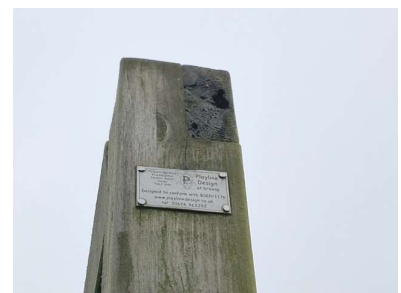
Timber is decayed.

Decaying around fixing points and top of vertical post.

Replace affected parts.

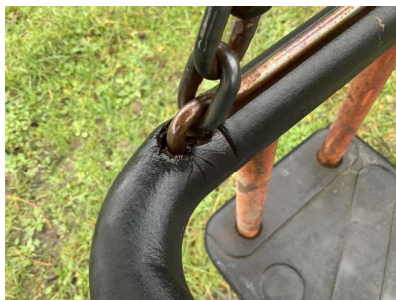
The bars on one of the cradle swing seats has failed and both chains have moved to one side of the seat, the links on the chain are worn, the half bar half chain is no longer used

Corrosion in cradle seat top frame could lead to sudden failure of the seat.

**Recommended council replaces 4 sets of chains and 2 cradle seats**

Investigate and replace as necessary.

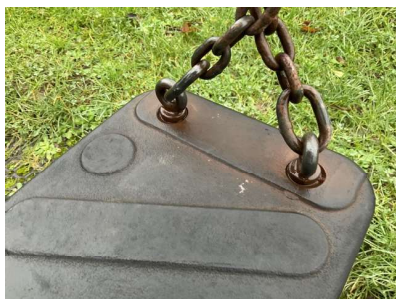
Loose swing seat eye-bolts.

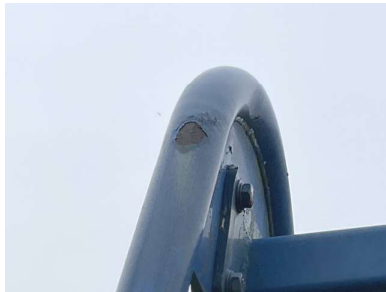
Item has corrosion.

Treat and repair.
