# Safety Inspection Report

Heytesbury Imber & Knook Parish Council

01 September 2025

Site name: **School Playing Field**  
Date of inspection: **01 September 2025**  
Inspector: **Jonathan Peters**

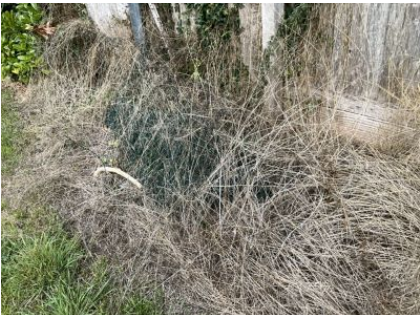
| Additional comments are noted below. |

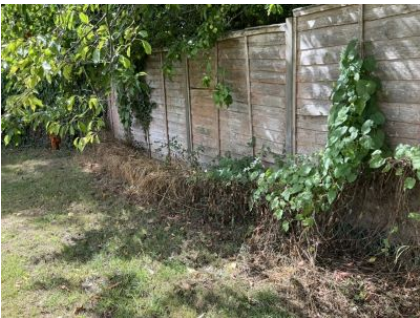
Minor repairs are needed.

Repair.

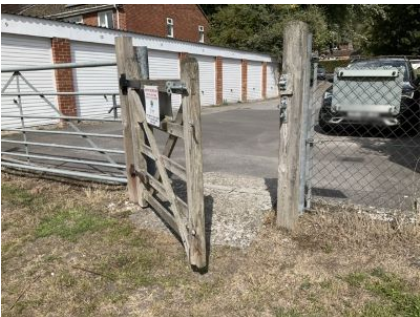
Additional comments are noted below.

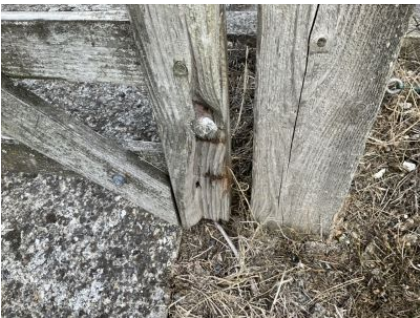
Item is damaged.

Repair.

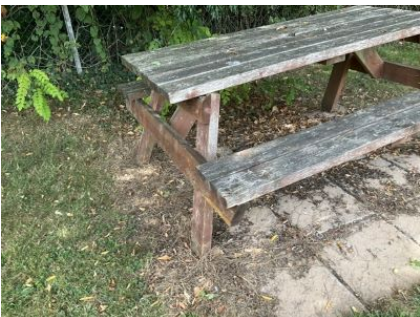
| Description |
|---|
| Moderate repairs are needed. |

| Description |
|---|
| Repair. |

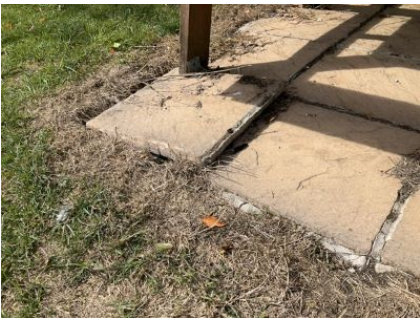
Minor repairs are needed.

Repair.

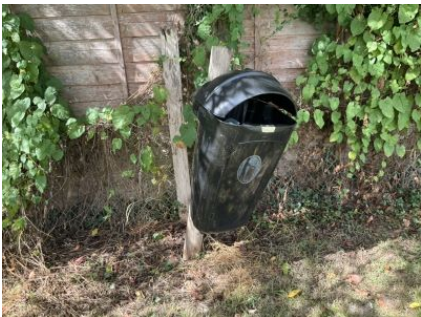
Loose in ground.

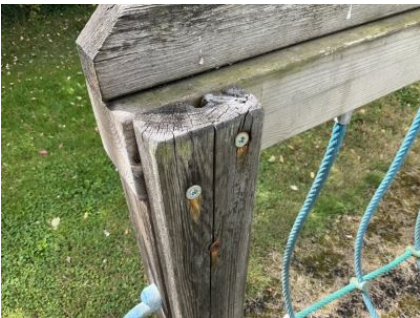
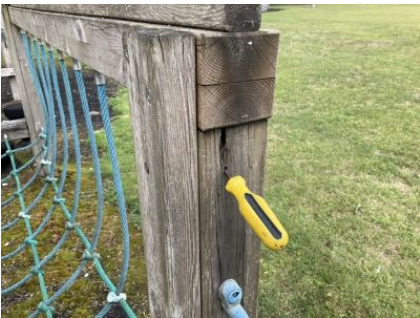
Timber is decayed.

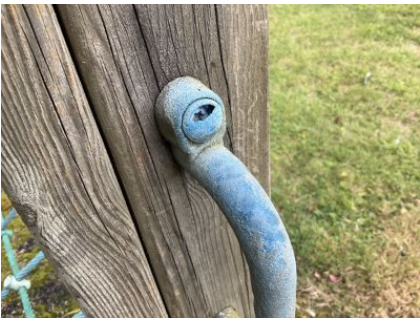
Bolt cap damaged.

Replace.

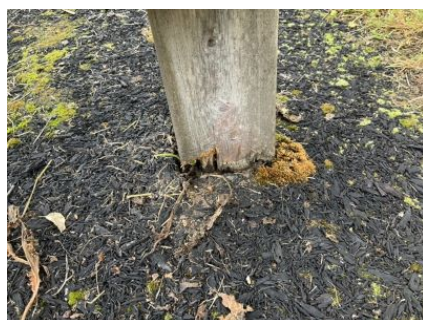
Timber is decayed.

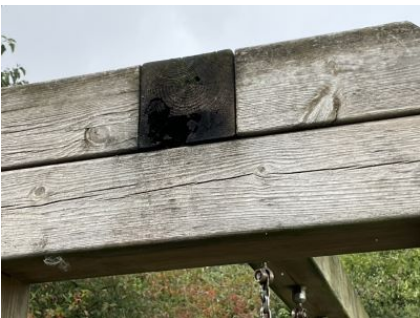
Timber is decayed.

Replace affected parts.

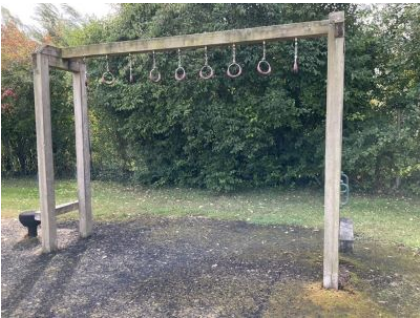
Overhead ladders and rings provide significant play value and benefits to children, and with it the risk of falling. Ensuring the surface remains in good condition will help to keep the correct balance between benefits and risk.

The protective surface under all bars and rings must be kept in good condition.

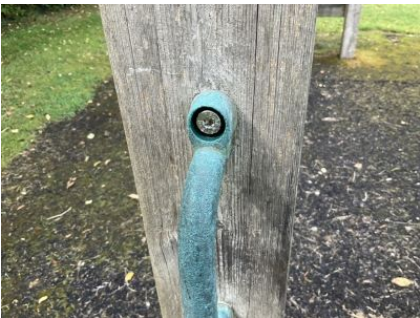
Bolt cap damaged.

Replace.

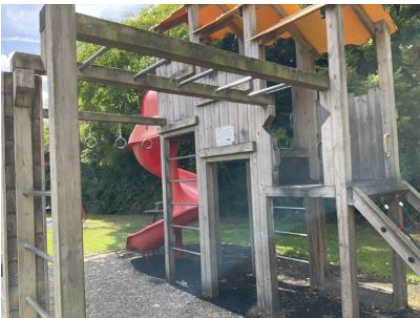
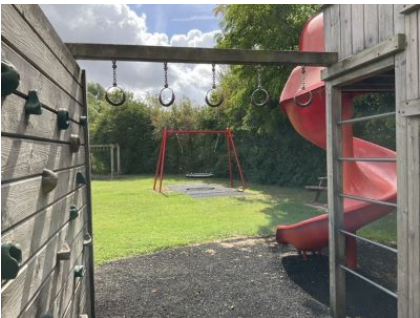
Overhead ladders and rings provide significant play value and benefits to children, and with it the risk of falling. Ensuring the surface remains in good condition will help to keep the correct balance between benefits and risk.

The protective surface under all bars and rings must be kept in good condition.

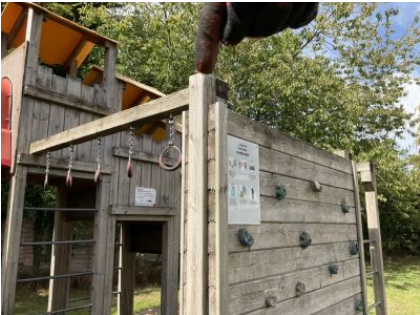
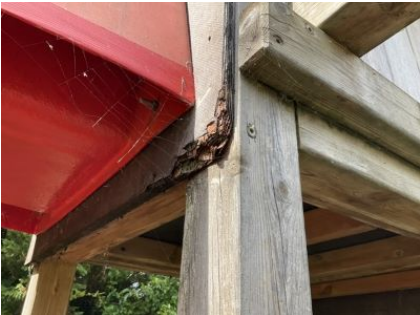
Timber is decayed.

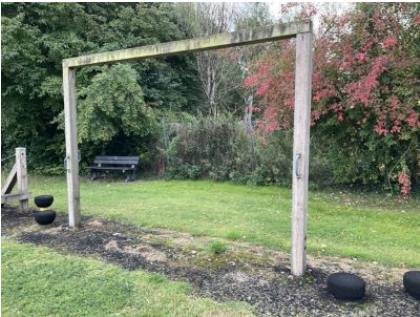
This equipment relies on one post for its stability. Special attention should be paid to maintenance (e.g. by monitoring degradation) and if necessary decommissioning the item before the end of its operating life. This is a requirement of the British Standard.

Routinely check for decay.

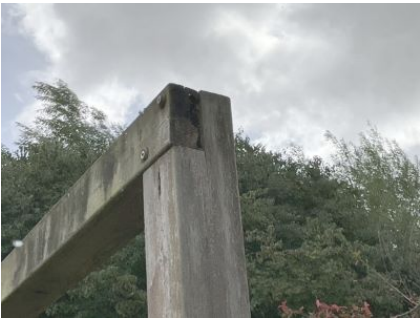
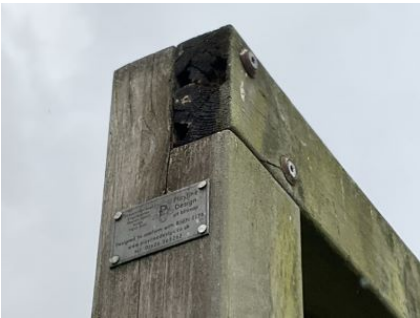
Timber is decayed.

Decaying around fixing points and top of vertical post. The ropes and treads have been removed, thereby reducing the risk score.

Replace affected parts.

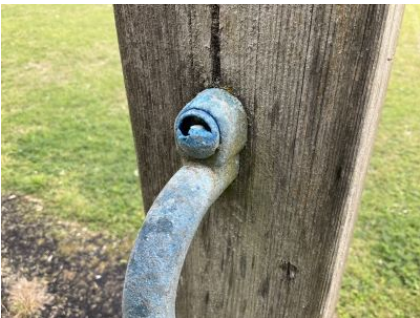
Bolt cap damaged.

Replace.

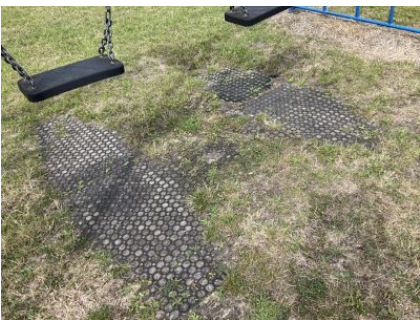
Surface is wearing.

Monitor for significant deterioration and rectify when necessary.

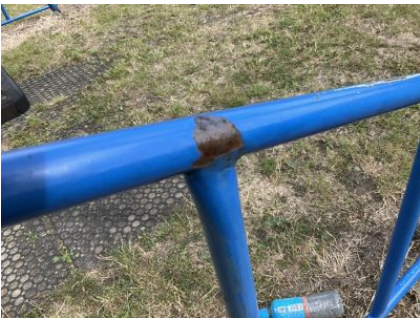
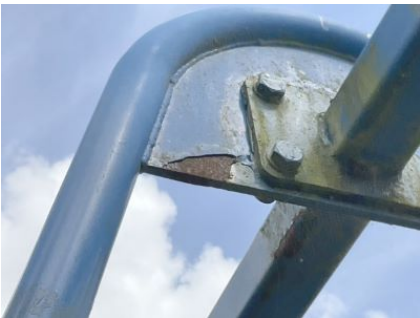
Item has corrosion.

Treat and repair.
